Marine Safety Investigation Report

File: EX-2020-54798228- -APN-JST#MTR

Type of accident: Very Serious Accident, one fatality

Accident: B/M Strategic Equity

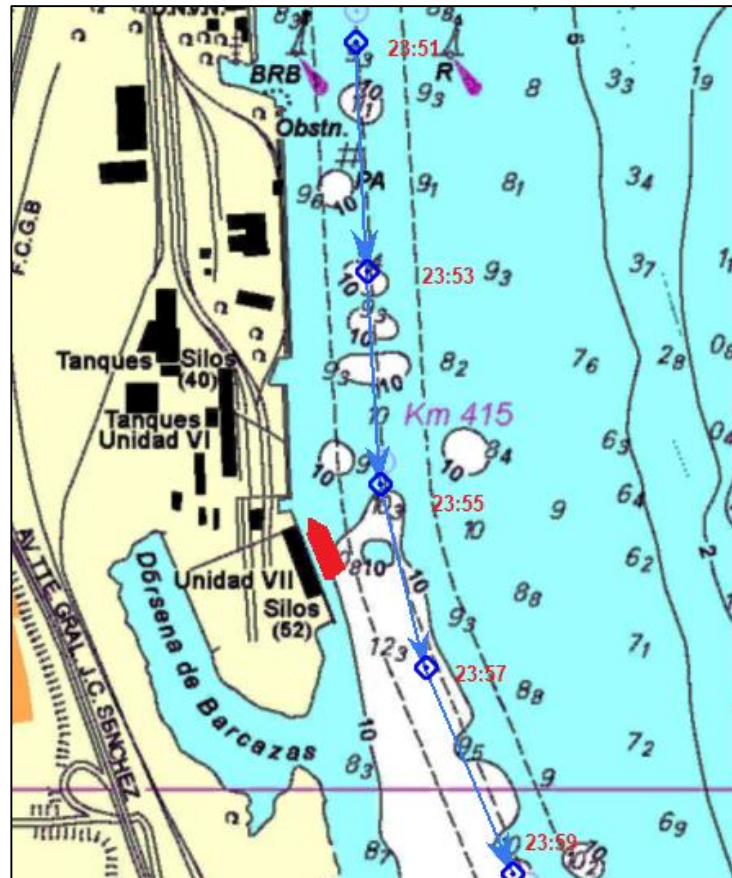
- On August 13, 2020, the Motor Vessel Bunga Lilac twice passed Strategic Equity position approximately 200 meters from its berthing position. At 22:32, it did so in an upstream (North) direction. At 23:54, it did so downstream (South), at a speed of 8 knots, with a draught of 9.5 meters.
- On August 14, 2020, the Motor Vessel Skyros passed the M/V Strategic Equity at 00:17 upstream.

Figure 4- M/V Bunga Lilac's track

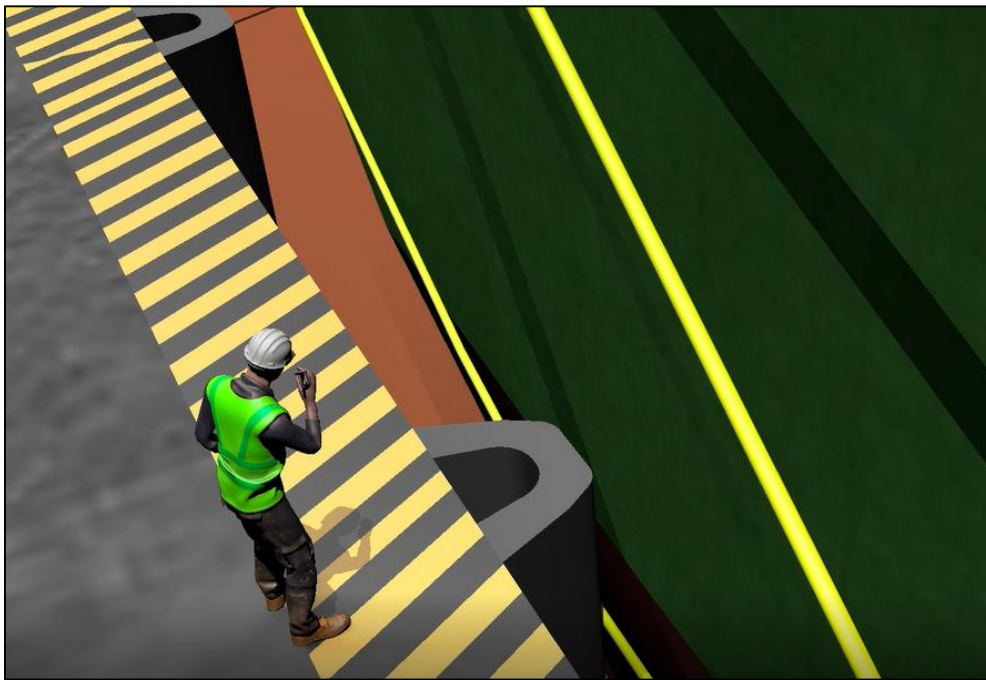
They indicated that approximately at 23:40, prior to the start of the loading operation, the chief officer went down to the quay to read the draft and observed that a forward spring was trapped between the dock fender and the vessel's hull.

Figure 5-Sketch of the position of the mooring observed by the Chief Officer from the quay.

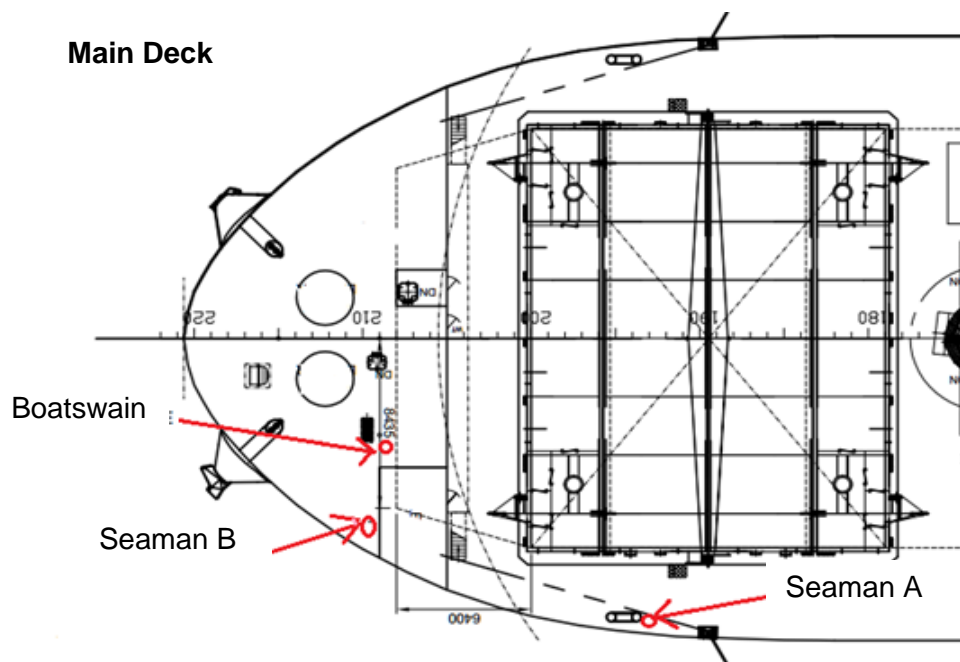
The boatswain stated that he went to the forecastle together with Seaman A and Seaman B, Seaman A was in charge of the signals, but he was out of the boatswain's line of sight. For this reason, Seaman A observed the state of the mooring and made the signals to Seaman B, who repeated the signals to the boatswain, who was in charge of operating the port winch.

Figure 6- Location of the crewmembers

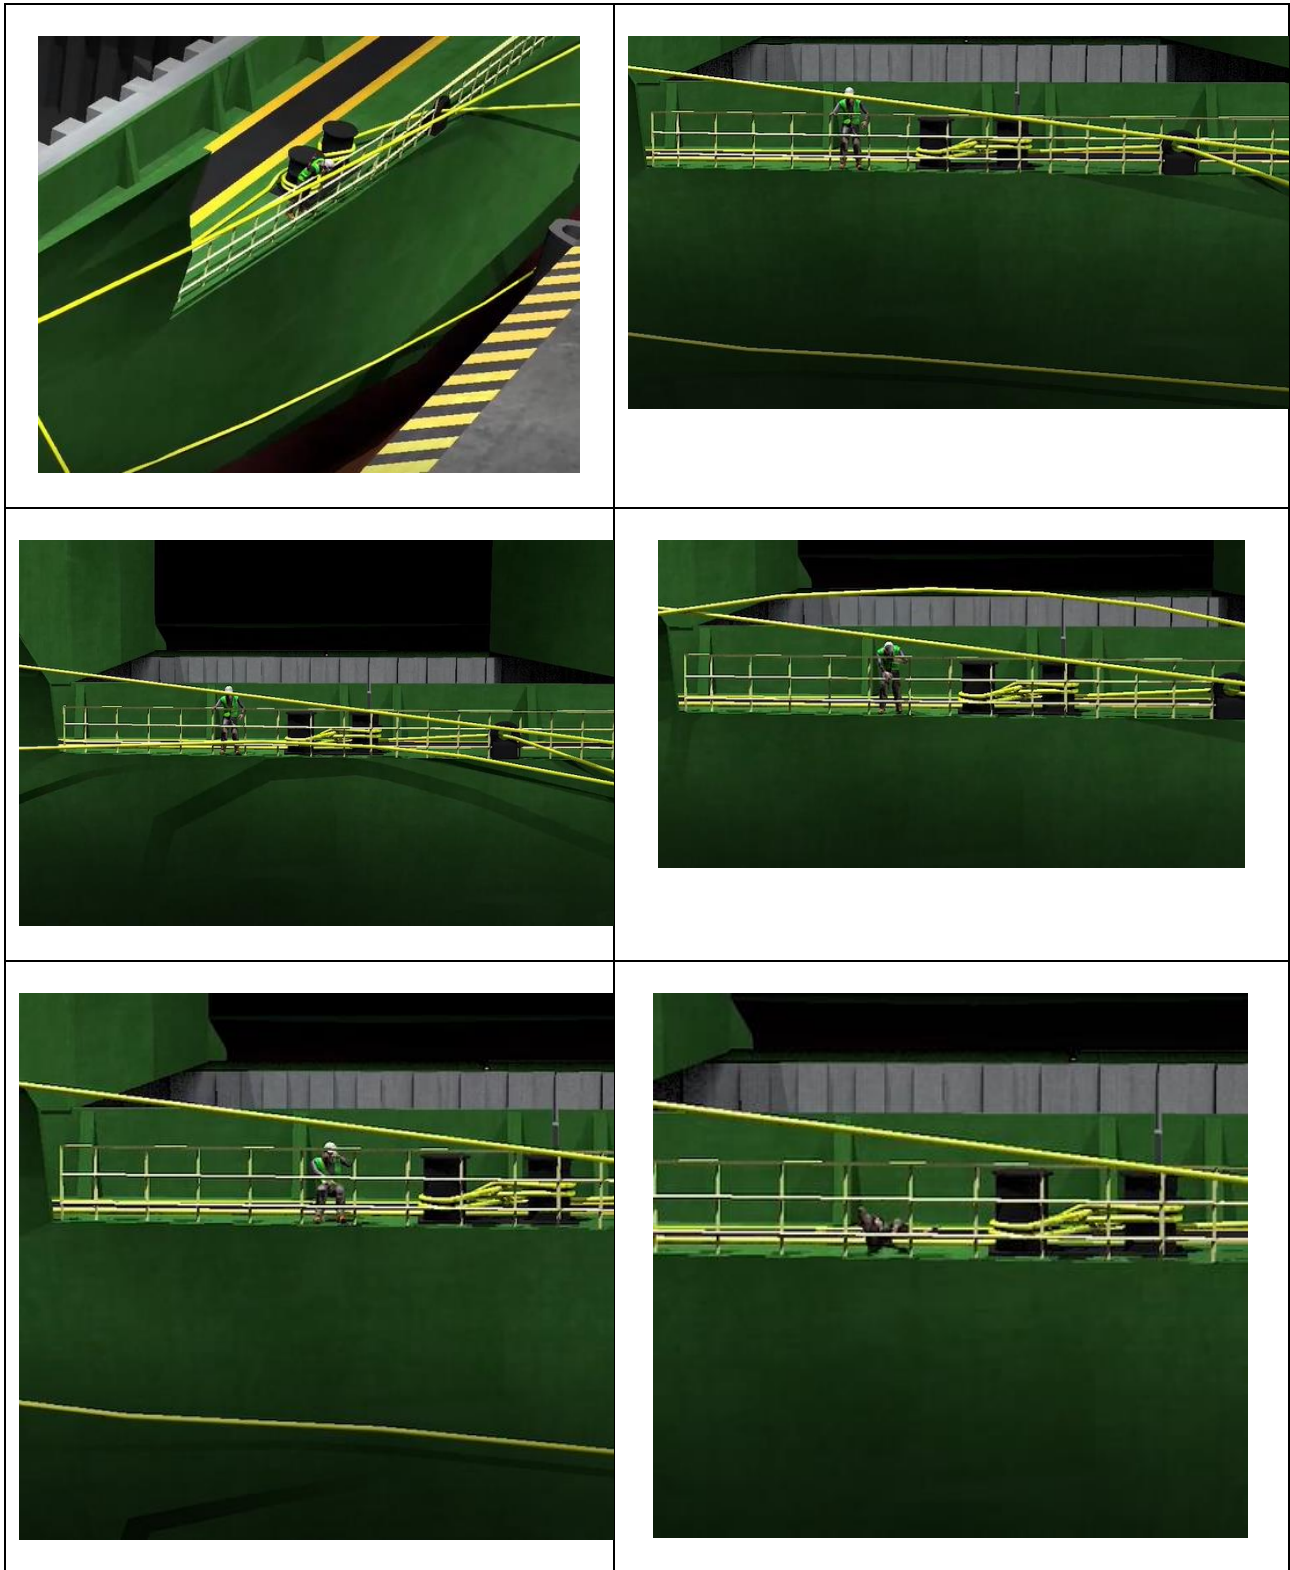
Suddenly, the forward spring broke free from its trapped position, released energy abruptly and generated an elastic upward rectifying movement that caused the impact on Seaman A's chin.

Figure 7- Mechanism of elastic release by energy accumulation

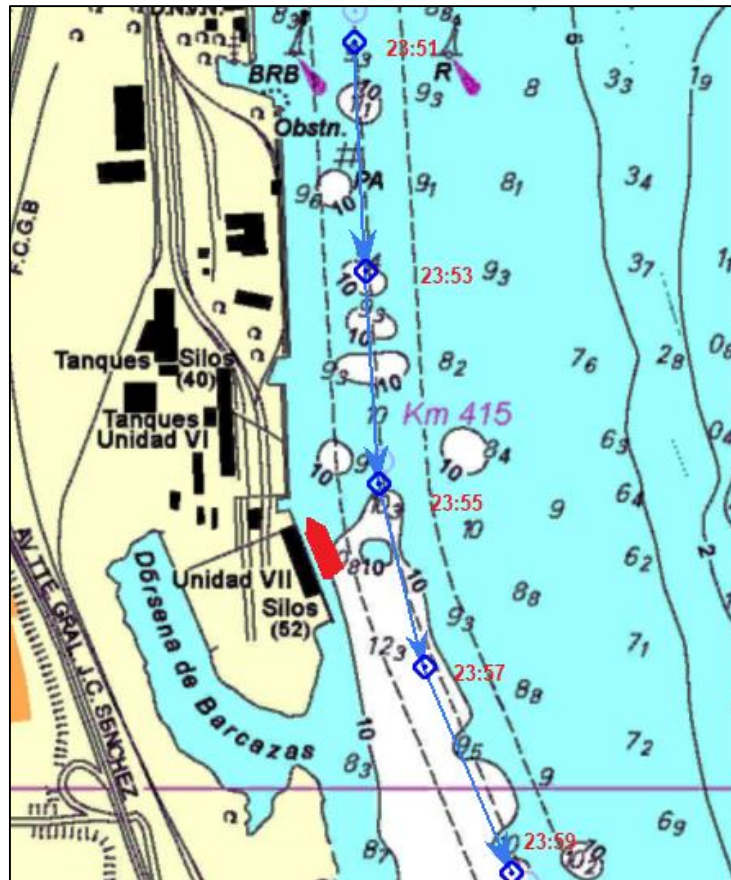
It is likely that the interaction caused by the passage of another vessel (the 147 m long, 25 m beam Bunga Lilac) affected the moored vessel at the exact time of the mooring operation and contributed to its sudden and unexpected release.

Figure 9- Moto Vessel Bunga Lilac's track

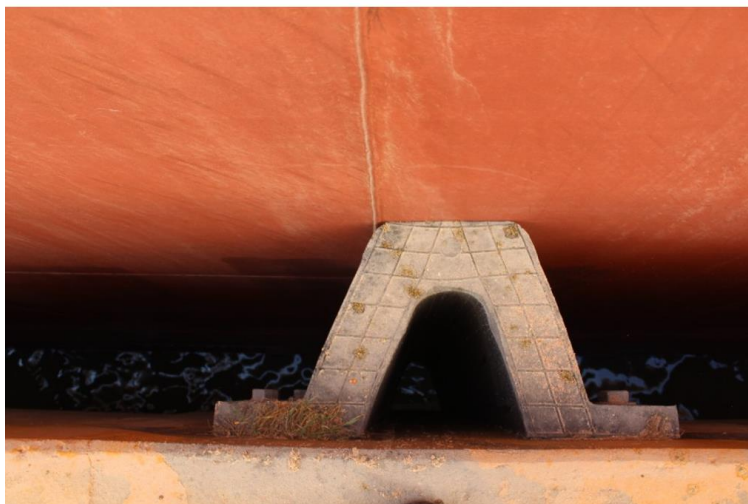
Figure 13. Photo of the quay fender involved
