MARITIME SAFETY INVESTIGATION REPORT
Rigid Inflatable boat (RIB)
ZODIAC 04
from
Mv WORLD EXPLORER
IMO 9871531

VERY SERIOUS MARITIME CASUALTY
Capsizing of a Zodiac craft
with loss of two lives

GAMA's registry 2022-492

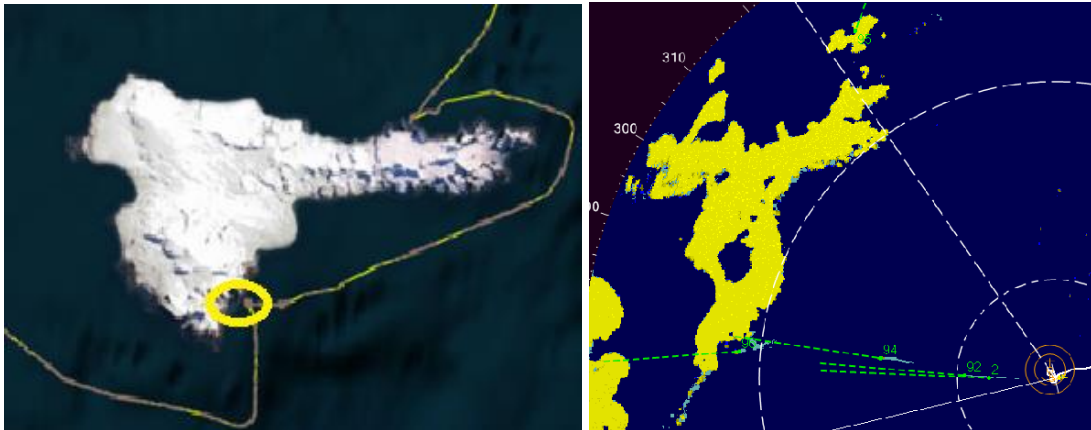
Figure 1 – Image of Elephant Island and location of the zodiac excursion.

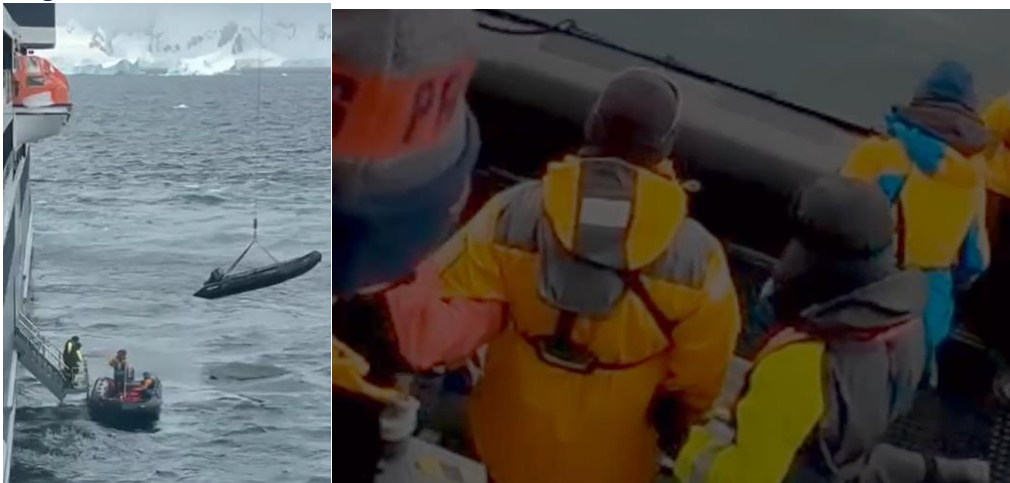
Figure 3

WORLD EXPLORER (WE) was at anchor, in the position indicated in figure 1, as part of a cruise chartered by Quark Expeditions. The planned activity for the day was an excursion to Lookout Cape, using inflatable boats (Zodiacs). Each Zodiac was crewed by staff of the charter's expedition team. The Zodiacs were prepared and lowered to the water by WE's crew and then delivered to the Quark staff. When the Zodiacs are crewed by the expedition staff, then the passengers embark the Zodiacs as indicated in figure 3 below;

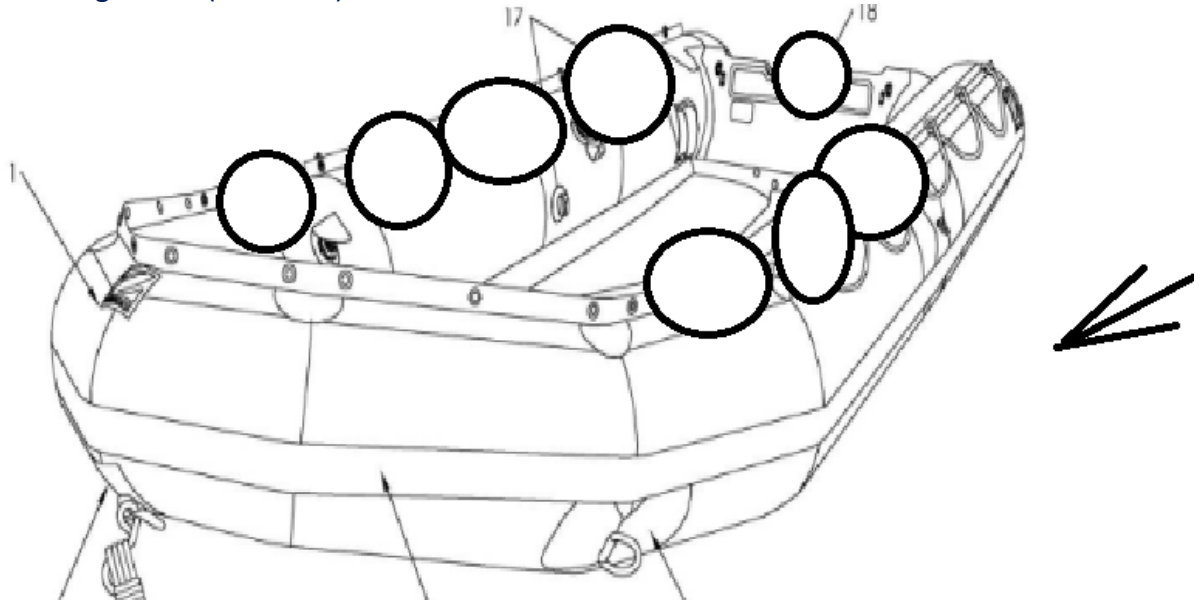
Figure 4 – Location of the driver, guests and Quark staff on starboard side and three guests on port side and direction of the wave that capsized Zodiac 04. The two guest that passed away were seated on port side.

Zodiac 04 was cruising westerly, in the direction of Lookout Cape, under way, using outboard engine, parallel to shoreline with a driver (Quark team lead), an ornithologist (Quark staff) and six guests (passengers) on board. The guests were seated three on each side of the Zodiac. The driver was standing on the stern

manning the Zodiac's tiller (engine) with his left hand. The guests and the Quark staff were all seated on the Zodiac's side pontoon sponsons (side inflatables boat tubes). The excursion was for wildlife sightseeing quite away off the shoreline, without landing. The driver stopped the Zodiac 04, about two hundred meters from the shore breaking waves (surf zone).

The bow of Zodiac 04 was heading towards the surf zone while all persons onboard were looking at wildlife. One guest seated forward on starboard side saw a wave about to hit the Zodiac 04 on her port bow and alerted the driver. The driver then turned the bow of the Zodiac 04 to port, in the direction of the wave. When he made this manoeuvre, the driver saw a large wave, approximately two meters, already cresting to break. He stated that there was no time to make an evasive manoeuvre. The wave hit the port bow and flipped the Zodiac upside down with the port side rolling over the starboard side. In figure 5 below is the location of the capsizing.

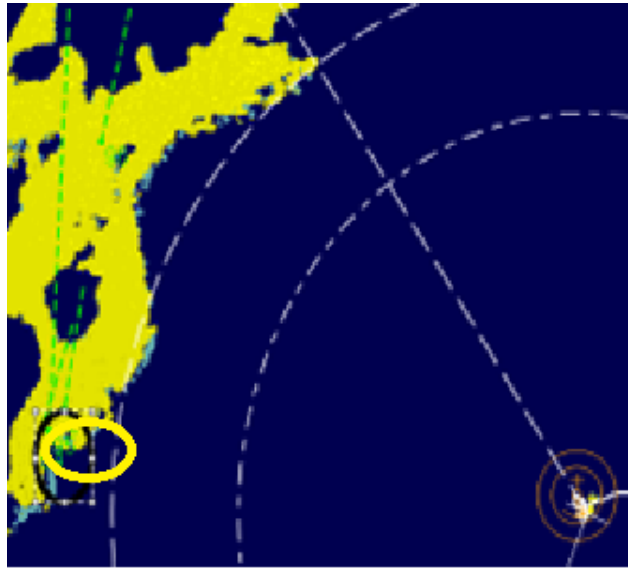
Figure 6

A VHF call is received in the bridge of WE's. The call was made by the Quark's staff on board the partner Zodiac and reported one Zodiac capsized and a MOB (man overboard) situation, on the west side of Pinguin colony. Assistance was requested. The Zodiac was in the indicated position in figure 6 below;

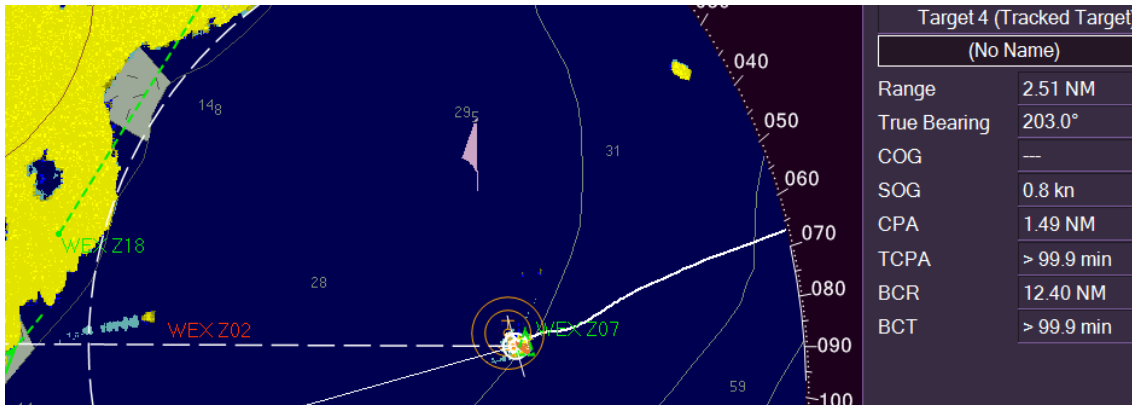
Figure 7

- 15/12/2022, at 18:44:24 hours
WE's bridge is informed that Zodiac 10 is lowered and on the water.
- 15/11/2022, at 18:47:57 hours
One Zodiac crew request, via VHF to the bridge, to move WE's closer to the MOB location. The distance from WE to Zodiac 04 is 2.51 nautical miles (nm) as indicated in figure 7 below.

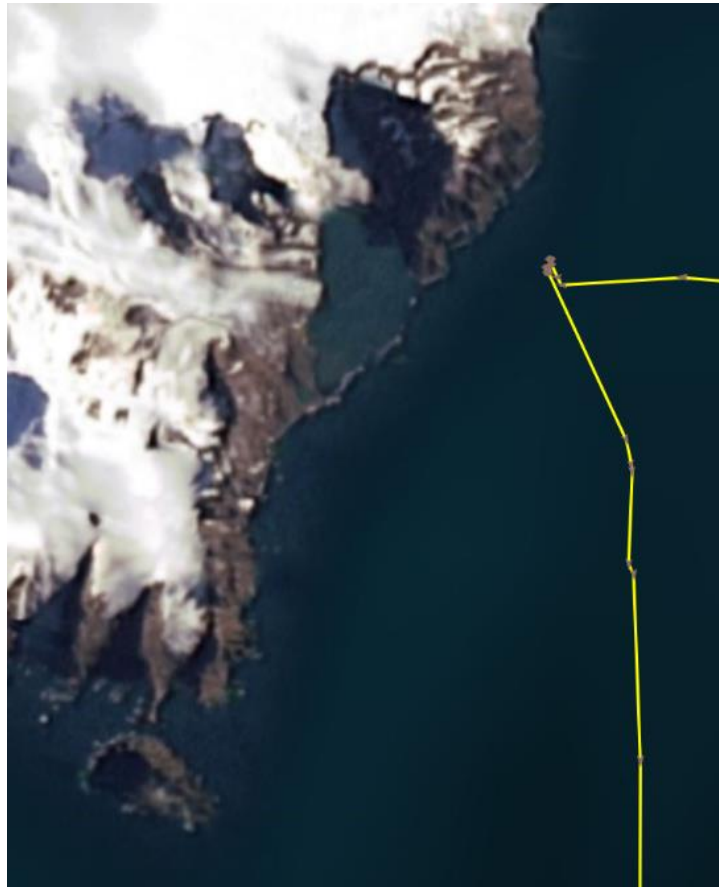
Figure 8

- 15/11/2022, at 19:11 hours
The WE's doctor is ashore and asks the bridge to send more medical equipment to the accident location. WE's is under way using engine and proceeding closer to the accident location, as indicated in figure 8 below.

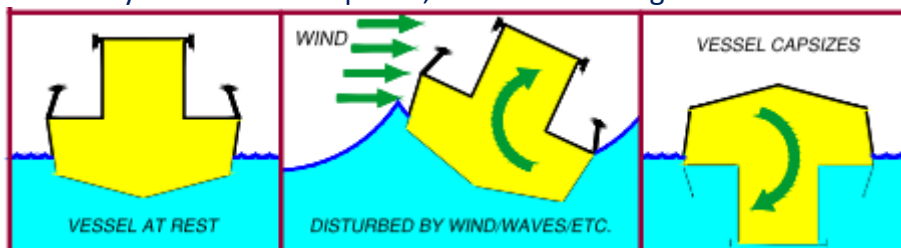
Figure 10

A stable vessel has sufficient stability to counter the external forces generated by weather and other forces and keeps or returns to its upright position. An unstable vessel does not have sufficient stability to counter the external forces generated by weather and capsizes, as indicated in figure 10 below.

Whether a vessel is stable or unstable depends on two factors, the moments acting to right the vessel (vessel's hull shape and loading) and moments acting to capsize the vessel (weather, sea conditions and movement of weights on board). As long as the moments available to right the vessel are greater than the moment acting to capsize the vessel, it will remain upright and is considered stable.

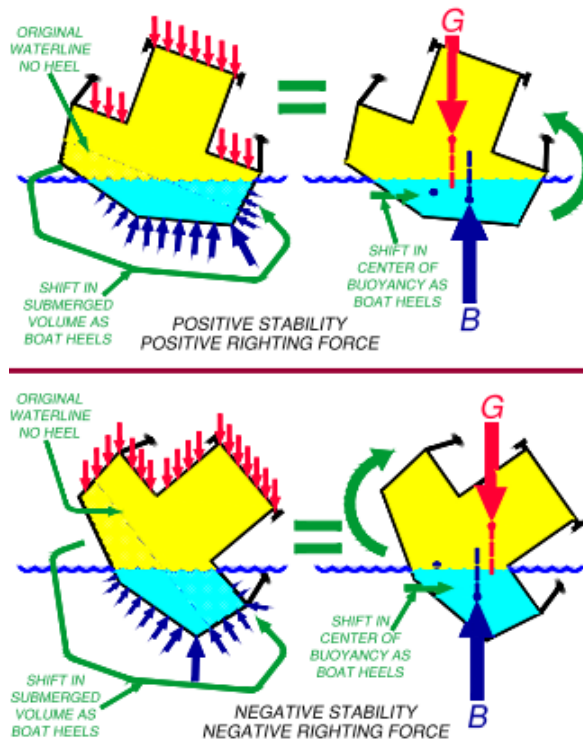
- The forces that create a vessel's stability are gravity and buoyancy. Gravity is the force acting to pull the vessel down in the water, making it sink and buoyancy is the force acting to push the vessel up in the water making it float.
- Positive stability is when the combination of the center of gravity pulling down coupled with the center of buoyancy pushing up creates a righting action that forces the vessel back to its upright position. Negative stability is when the combination of the center of gravity and the center of buoyancy creates a capsizing action that forces the vessel to continue to roll over. Figure 11 below from United States Coast Guard 'A best practices guide to vessel stability' indicates these two moments.
